SYSTEM BRIEF DETAIL

Test report detailing the testing and classification of an aluminium rainscreen façade system with mineral wool insulation tested in accordance with the requirement as described in British Standard 8414

BS 8414-2:2015+A1:2017 Test Report with
Classification in Accordance with BR135

Report Reference: 102217.8414

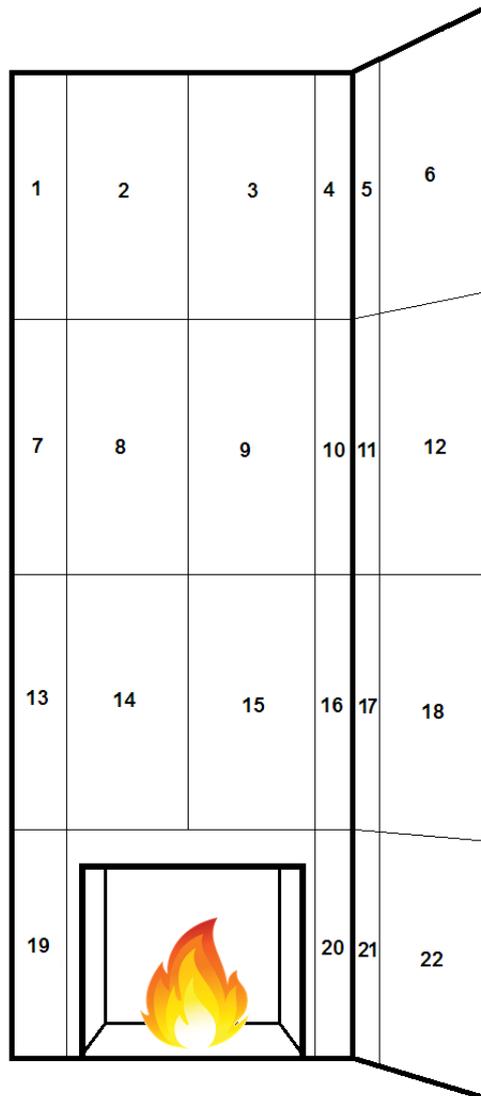
Figure 7 – Façade Panel Numbering

05.50	Smoke emerging from behind panels 2 & 3
06.15	Panels 14 & 15 warped, with visible flaming behind
07.20	Panel covering lintel area melting/degrading, pieces of debris falling – 1-20 cm

09.00	Panel 15 begins visibly melting
11.10	Piece of debris ~30 cm, falls from around panel 14
16.40	Piece of debris ~70 cm, falls from around panel 14
24.10	Popping sounds begin

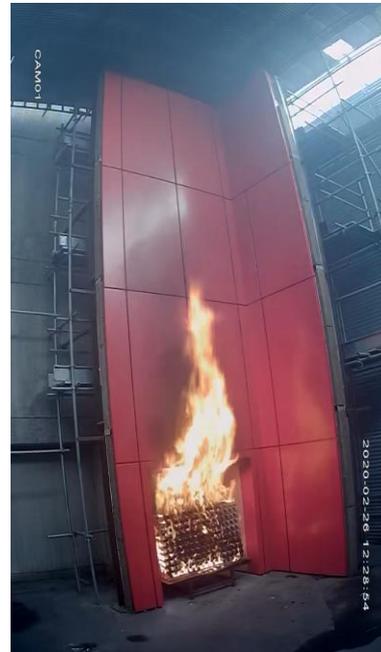
Figure 9 – 05:00 after ignition

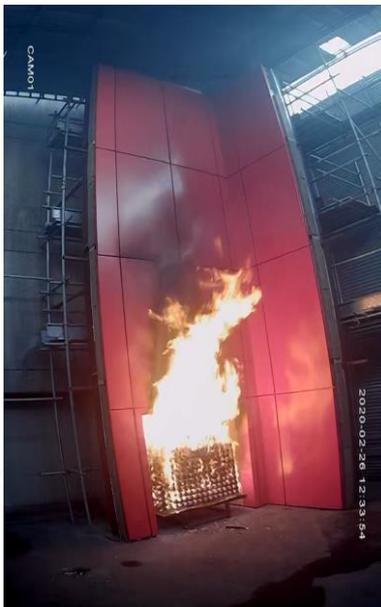
Figure 10 – 10:00 after ignition

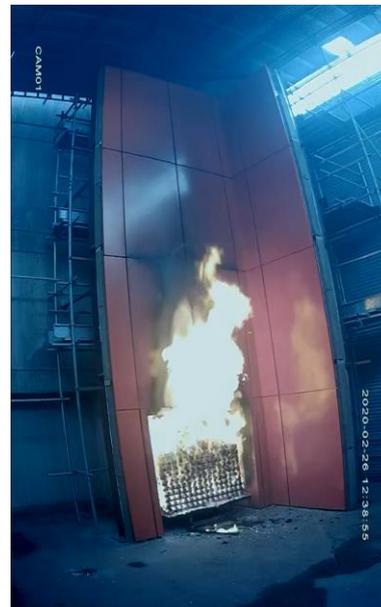
Figure 11 – 15:00 after ignition

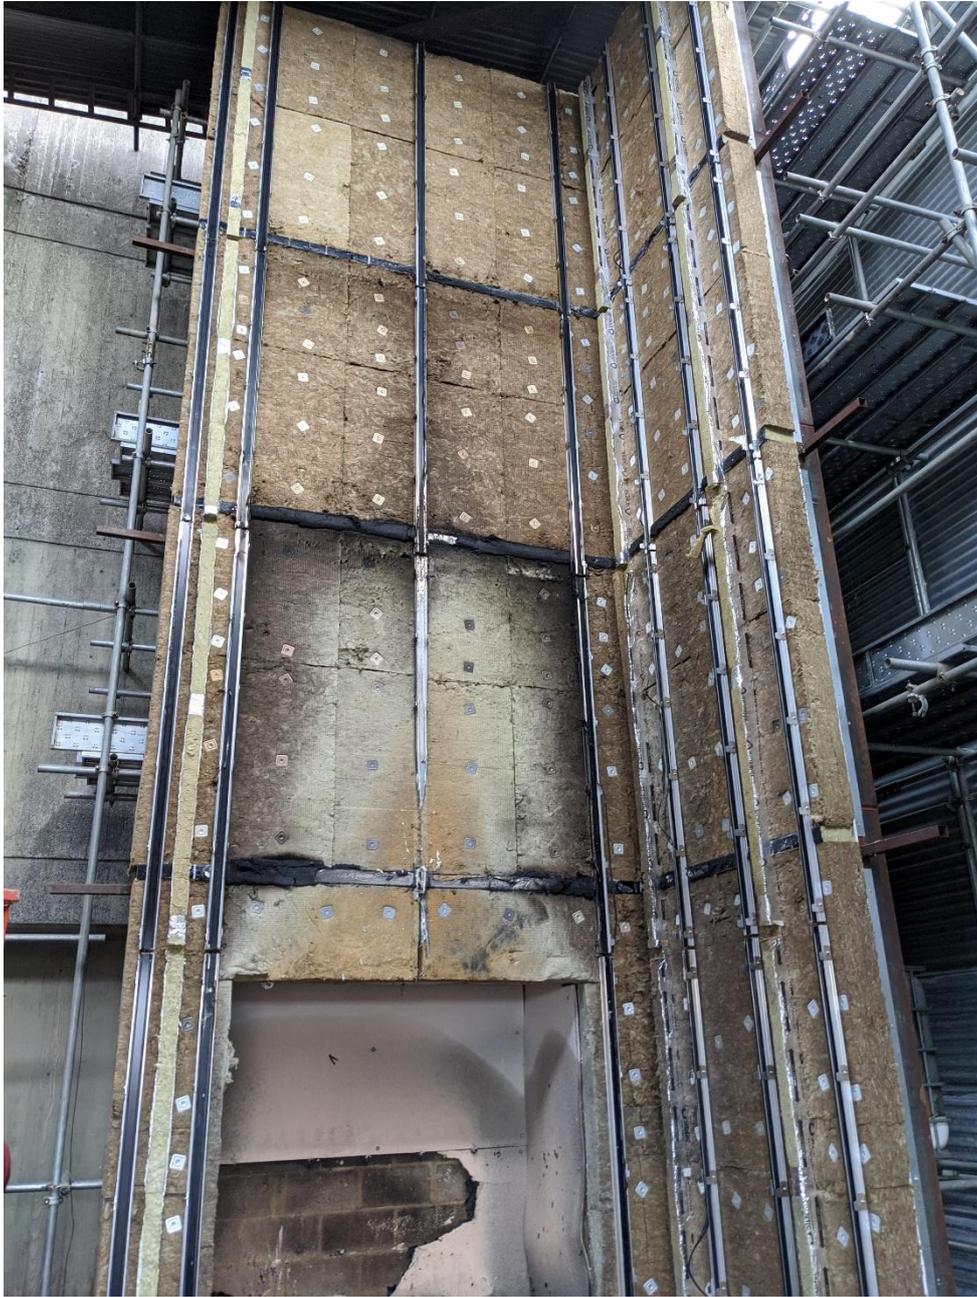
Minor scorching was observed on the sheathing boards around the burn chamber opening, and further small signs of heat damage were found further up the wall, however this was not found to affect the structural integrity of the boards.

Figure 22 – Rainscreen removed, scorching observed between cavity barriers

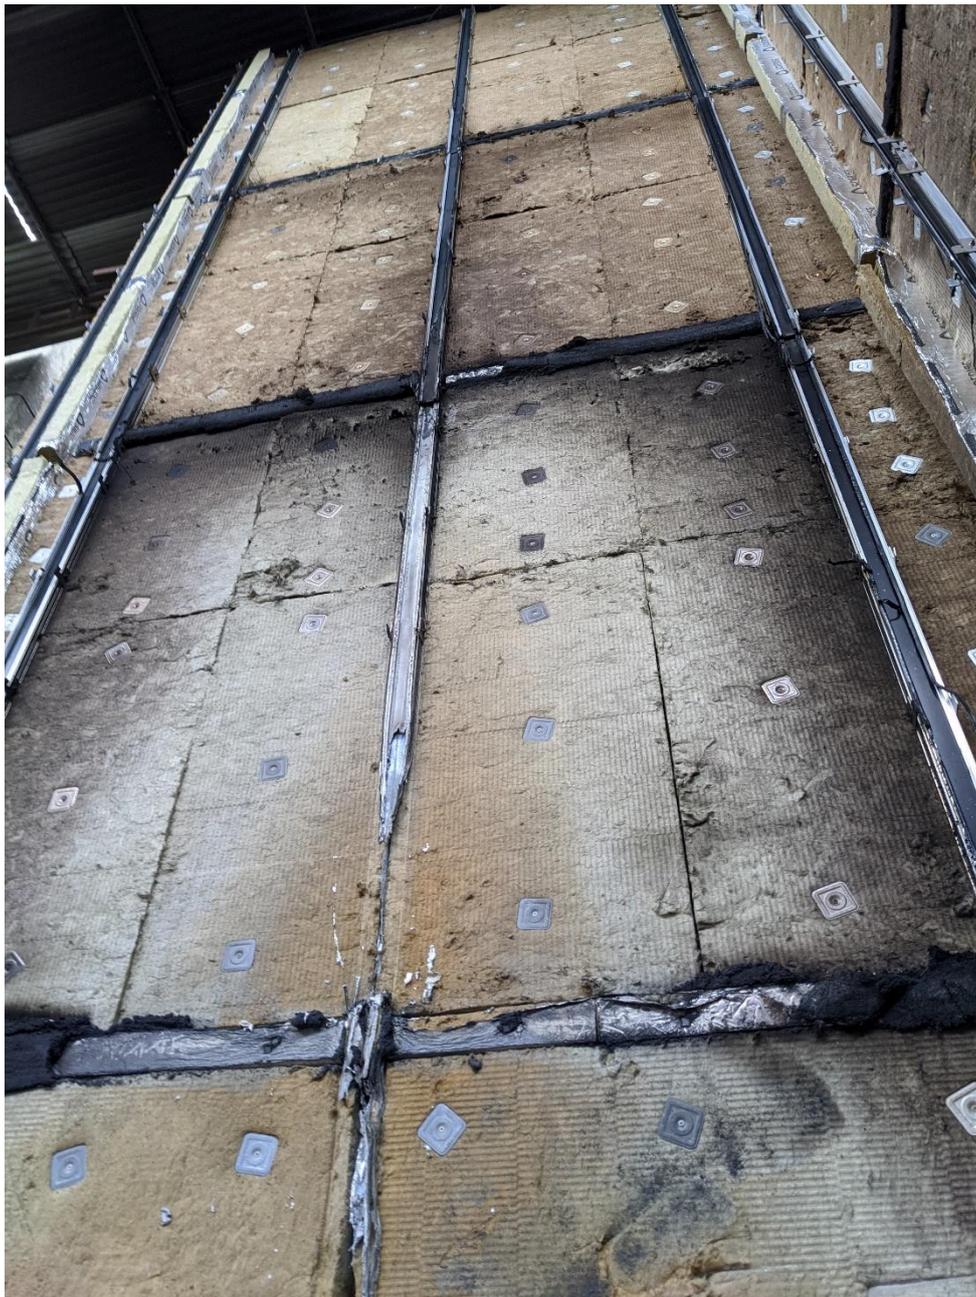
The horizontal cavity barriers appeared to have operated as intended, preventing the vertical spread of fire.

Figure 23 – Intumescent activation on cavity barriers clear to see, metal fixings for insulation all in place

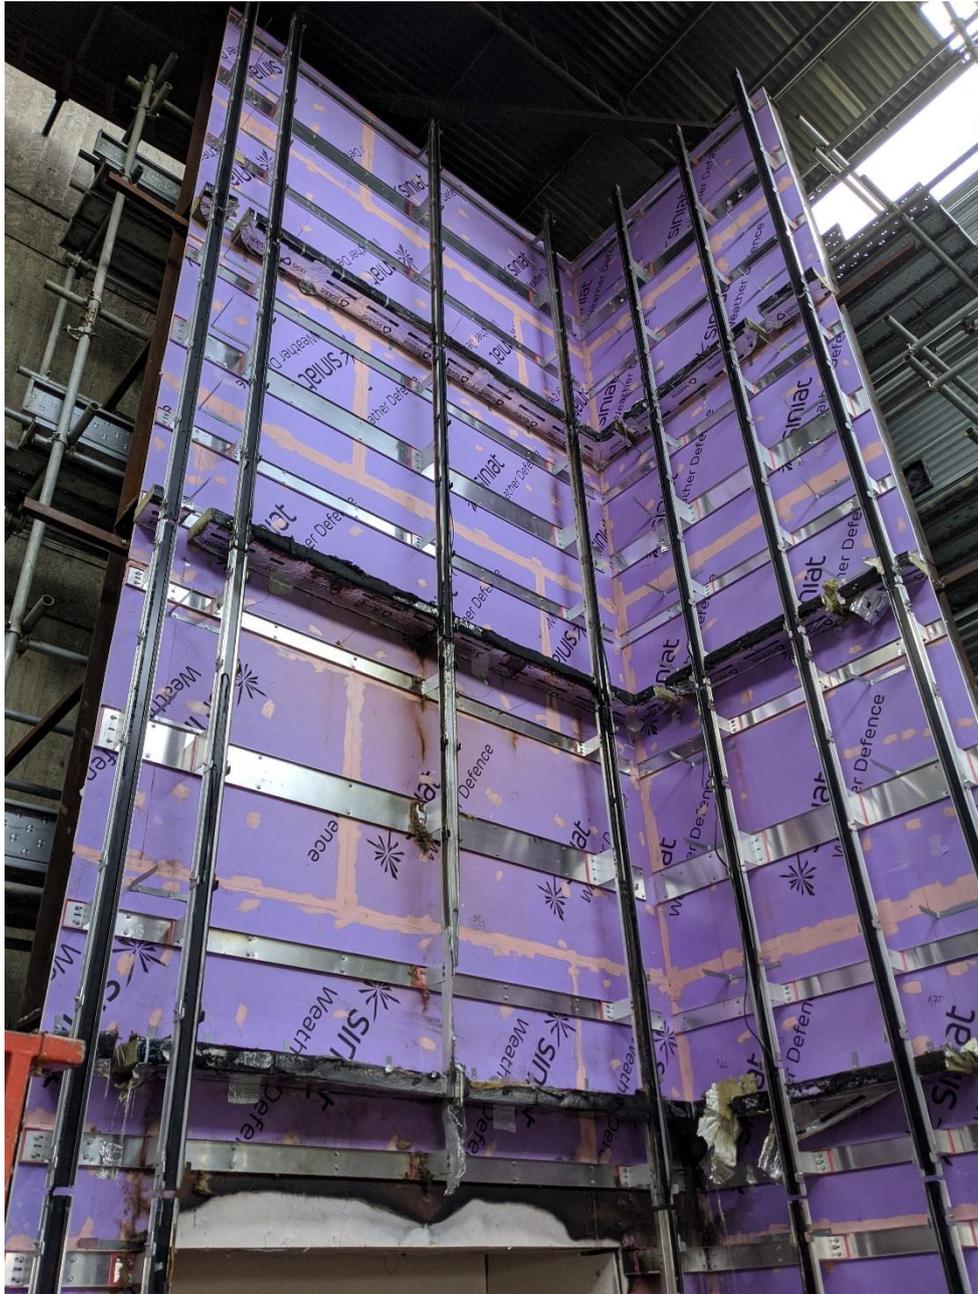
Minor discolouration was observed on the rockwool insulation, however there was no evidence of fire breaking through the insulation layer.

Figure 24 – Insulation removed, light scorch marks on sheathing boards visible and damage to vertical rails clearer

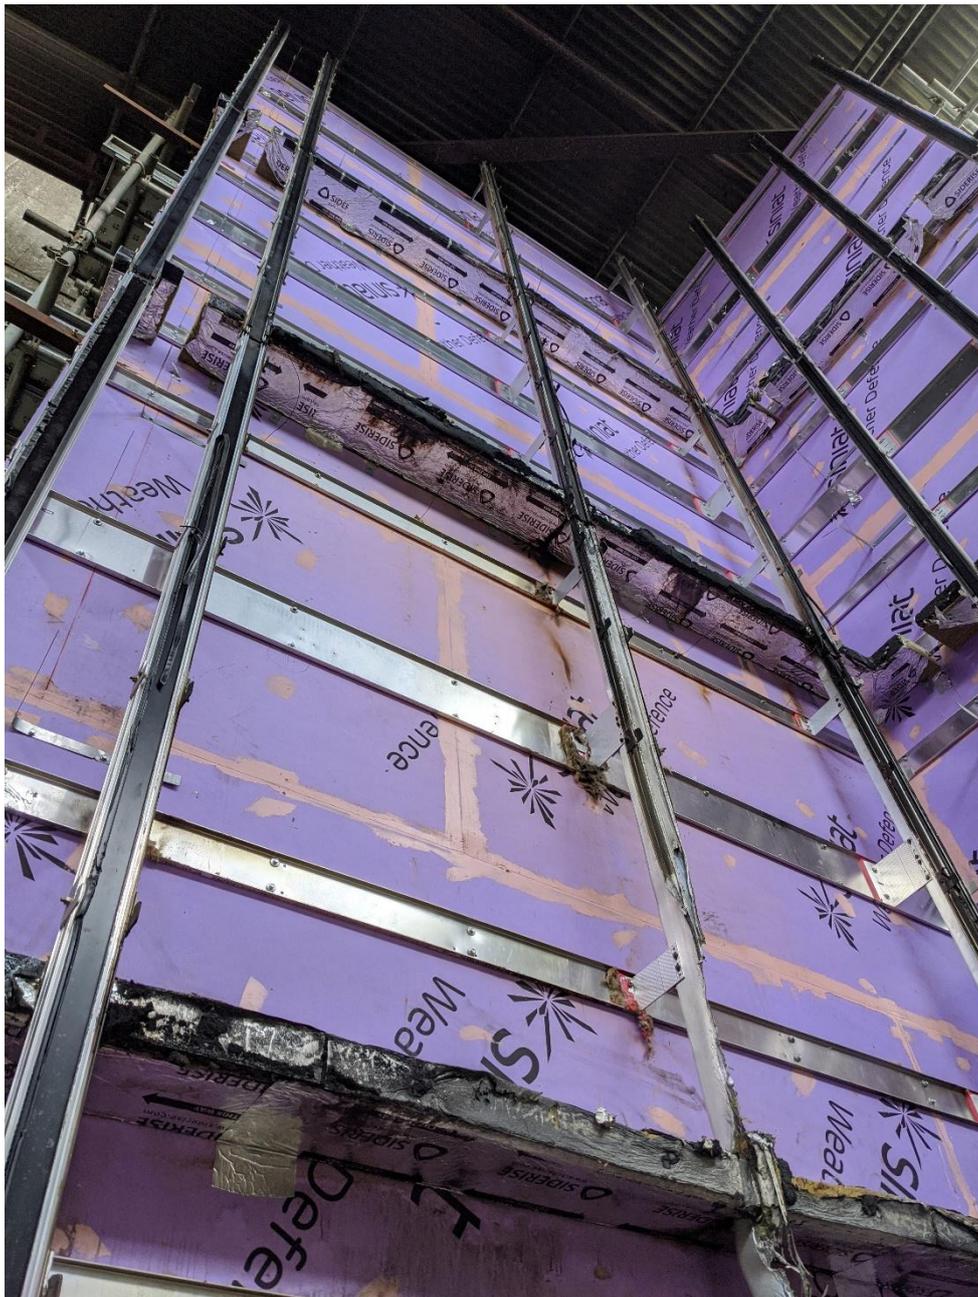
The brackets and rails had melted away in the areas that suffered direct flame impingement from the fuel source, however all other rails maintained structural integrity and none of the façade panels became loose or fell during the test.

Figure 25 – Further detail of damage to vertical rails, both above and below lower cavity barriers
